**WESTBROOK BOARD OF EDUCATION
Tuesday, January 9, 2024 @ @ 5:00 p.m.
Fiscal and Facilities Subcommittee
Superintendent's Office**

2023 CAPITAL REPLACEMENT PLAN

Facility Assessment Study *Daisy Ingraham Elementary School*

Facility Assessment Study *Westbrook Middle School*

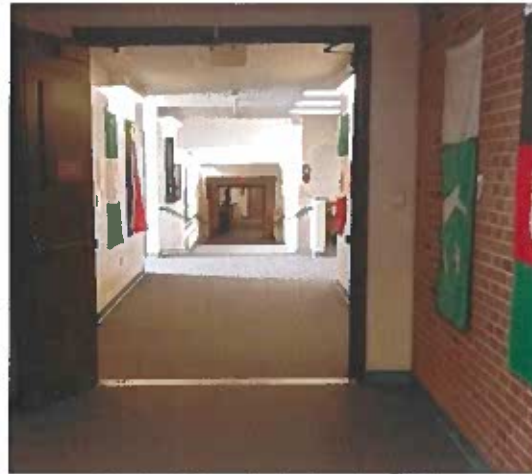
The carpet throughout appeared to be in good overall condition. It was reported that the carpet was replaced in 2016. Based on the estimated Remaining Useful Life (RUL), carpet will require replacement during the assessment period.

Replaced Carpeting in Corridors 2016

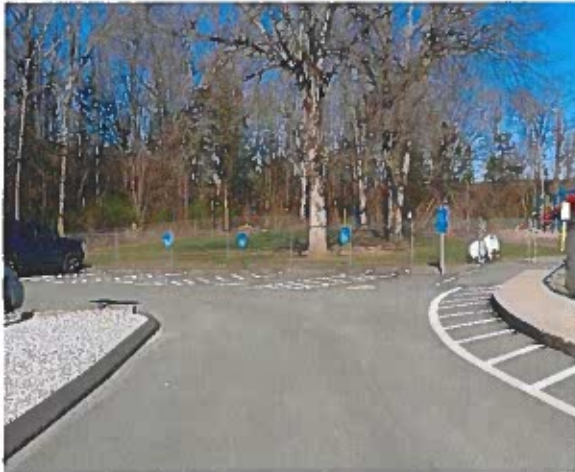
Curb ramps are required from the parking area to the sidewalks providing access to the building. There are two curb ramps, one at each accessible parking area that are not in compliance with the ADA code. These may require replacement.

Parking Area South, Handicap signage and van accessible

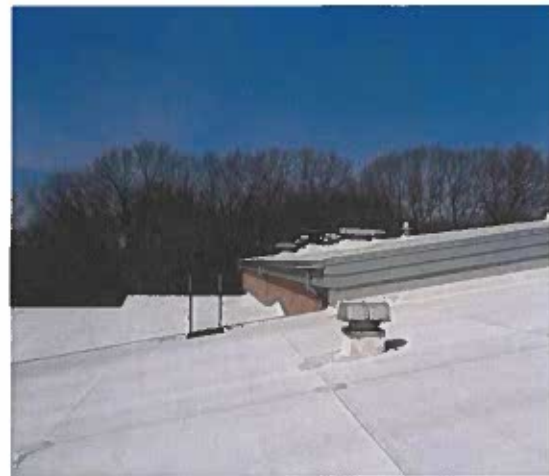
The roof membranes are in good condition. Based on their estimated Remaining Useful Life (RUL), the roof membranes will require replacement during the assessment period. The cost of this work is included in the Replacement Reserves Cost Estimate (Table 1, page 4).

Membrane Roof

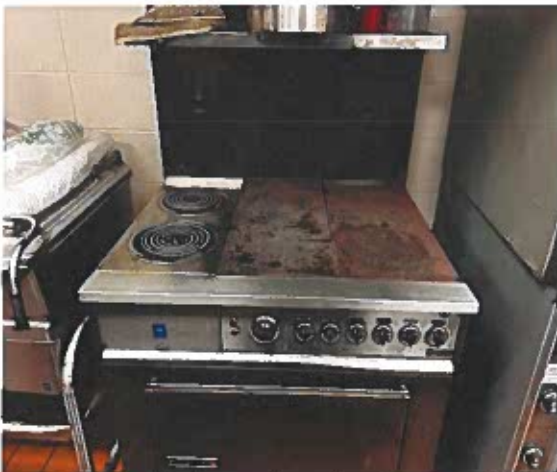
| Capital Item | Total Replacement Cost | Cost |
|---|---|---|
| Kitchen Stove | Commercial electric to be replaced | \$5,000 |

Stove to be replaced

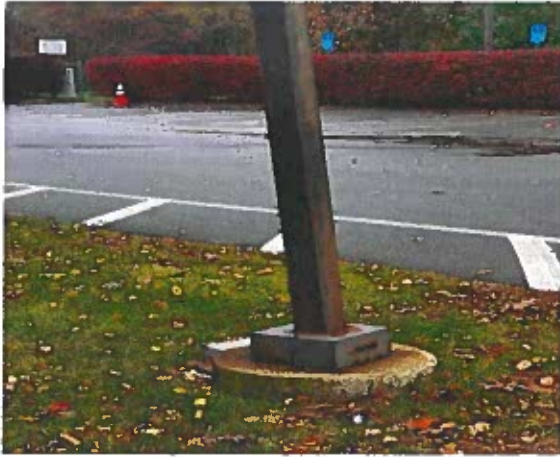
The exterior site and building light fixtures are in fair to poor overall condition.

Light Pole with rusted base, recommend replacement

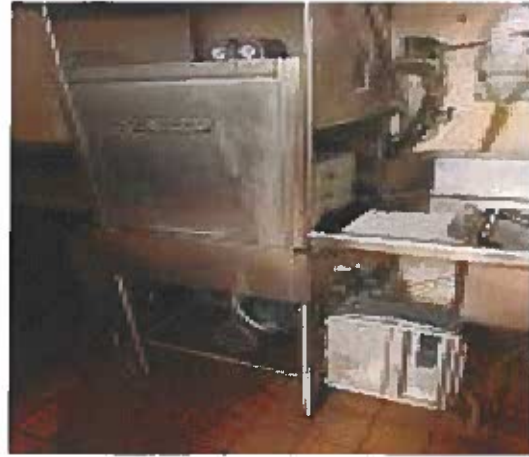
| Capital Item | Total Replacement Cost | Cost |
|---|---|---|
| Dish Washer | Commercial Hobart to be replaced | \$18,000 |

Dishwasher recommend replacement

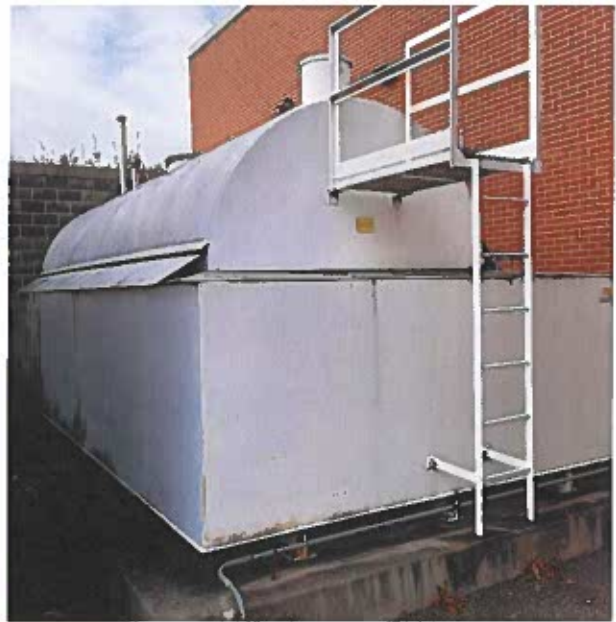
Obsolete 8,000-gallon Oil storage tank

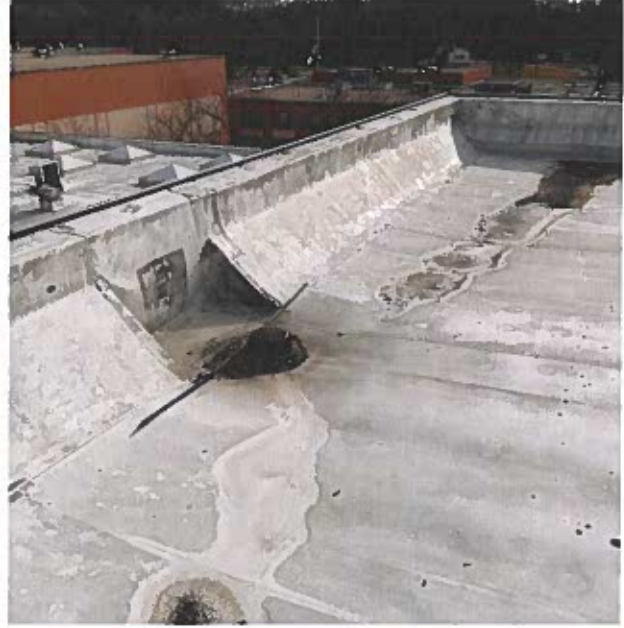
Roof drain and ponding

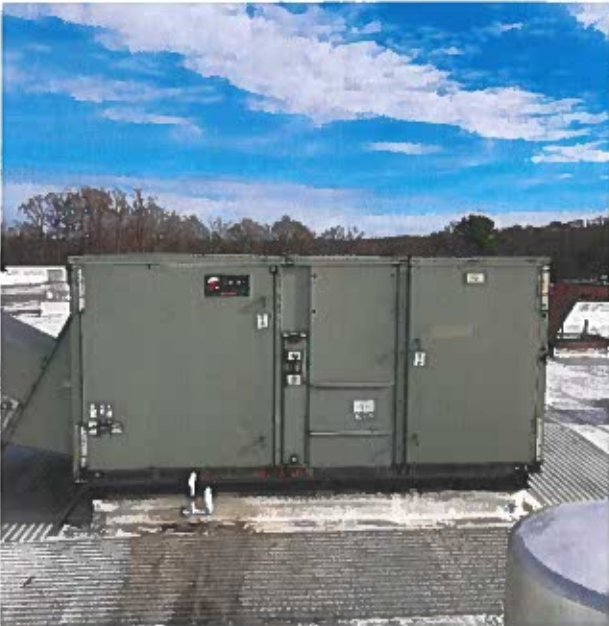
RTU -1 Library, poor condition

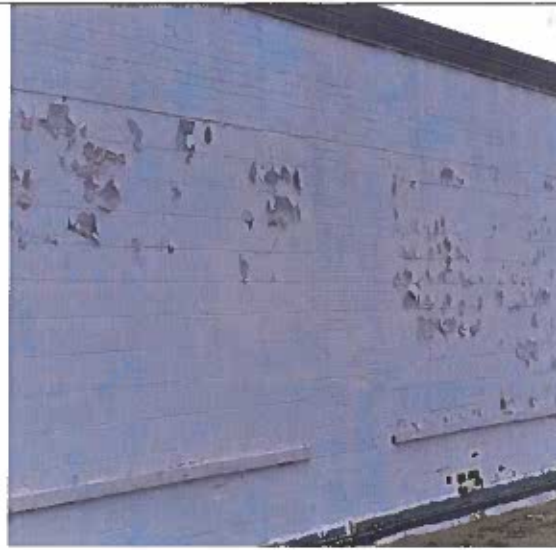
Upper Gym wall-CMU block, leaking needs
significant repair

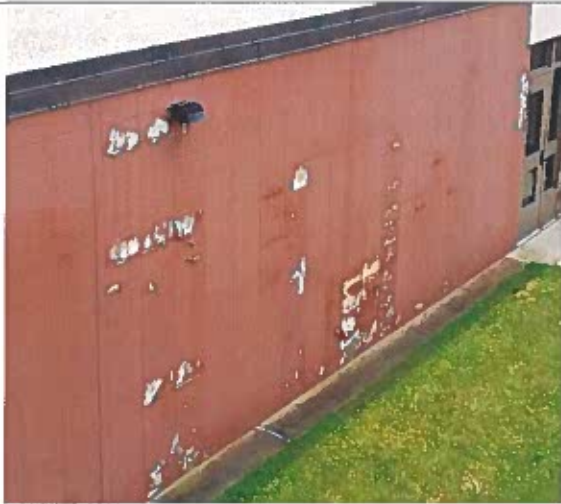
Exterior CMU wall
(Maintenance required)

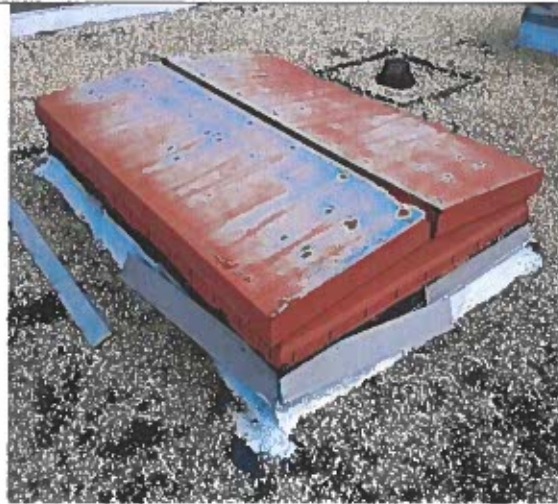
Flashing of the 3-auditorium smoke
hatches, needs to be addressed

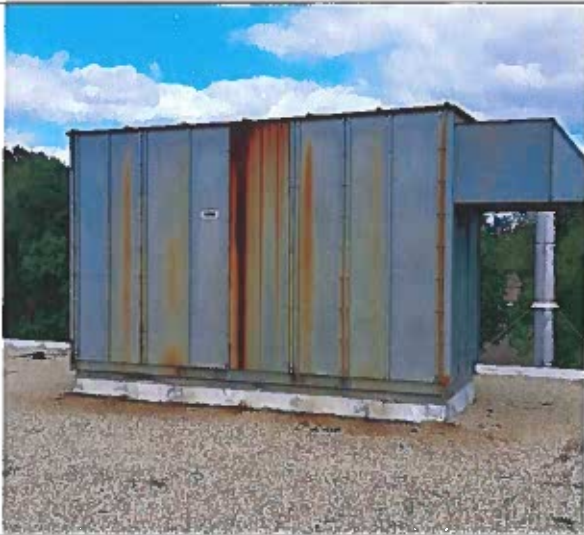
Practice Gym RTU
Typical condition of most units
(29 years old)

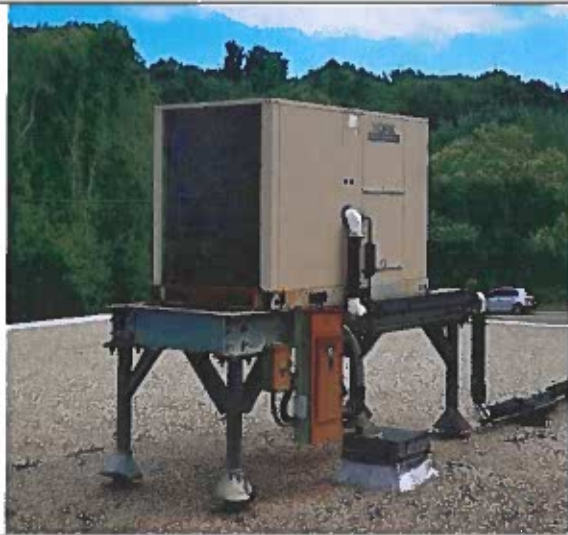
Stage Roof Top Unit, out of commission,
should be removed

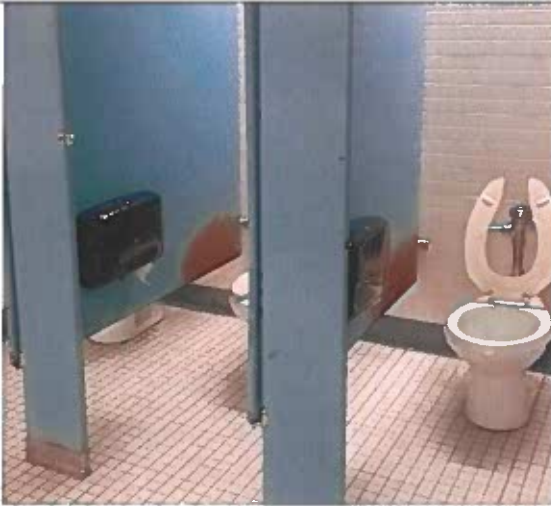
Boys' bathroom panels, C wing
(Poor Condition)

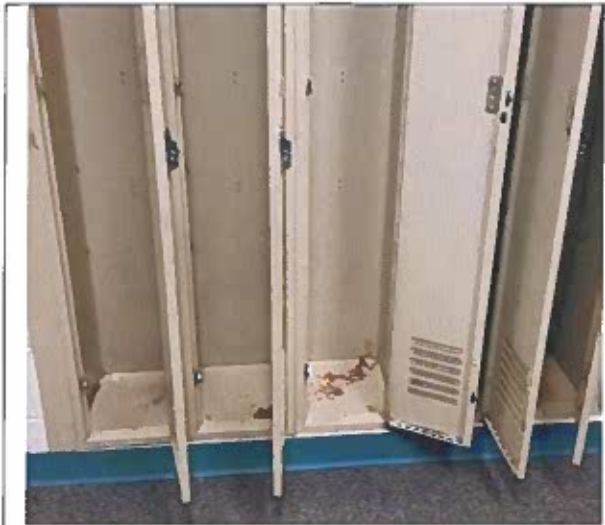
Lockers
(good, fair and poor condition)

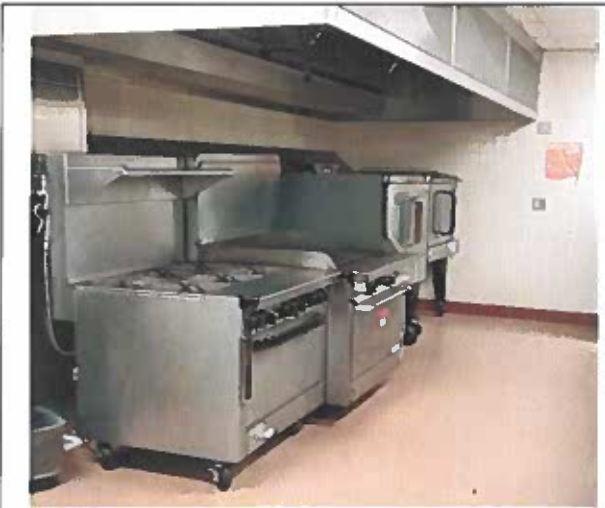
Original exhaust hood
(Poor Condition)
