District Wide Facility Assessment

Yough School District

April 8, 2024

District-Wide Facility Study

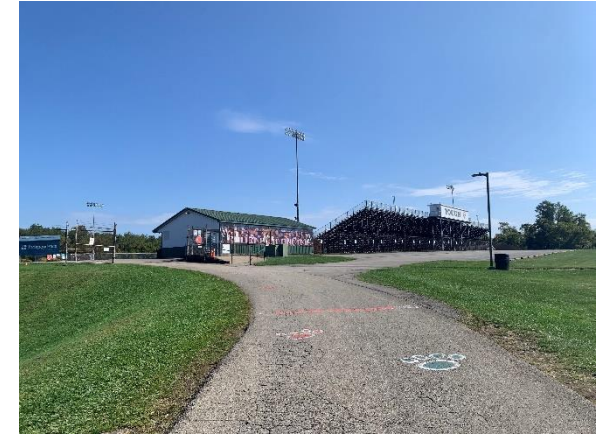
CRACKS IN PAVEMENT

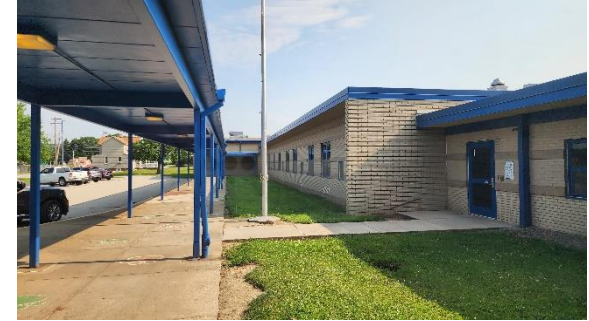
ROUTINE MAINTENANCE TO BUILDING PERIMETER

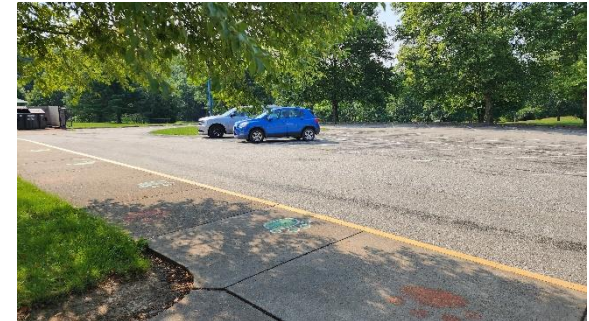
INADEQUATE PARKING CONDITIONS

- Recommendation: *Re-route parent drop-off and pick-up through new paved lot. Lot can be used for faculty and off hour school functions.*
- Routine maintenance to building perimeter, play area, and garden conditions.

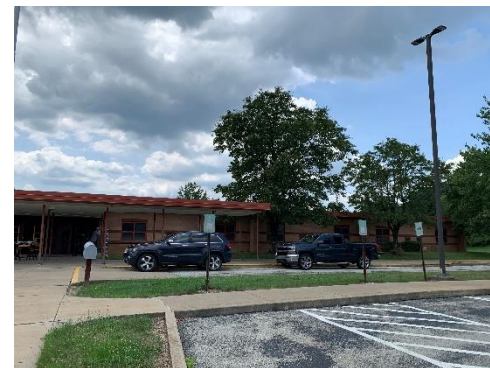
ADA TRAVEL PATH NECESSARY FROM ASSIGNED ADA PARKING

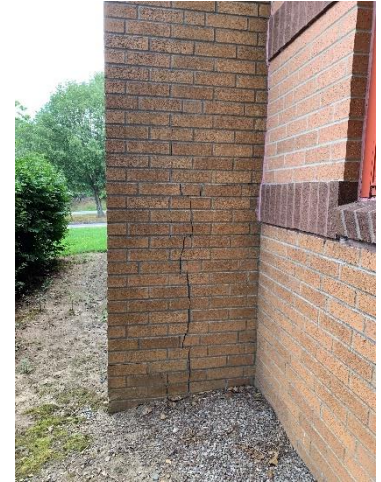
CRACKS AROUND PERIMETER

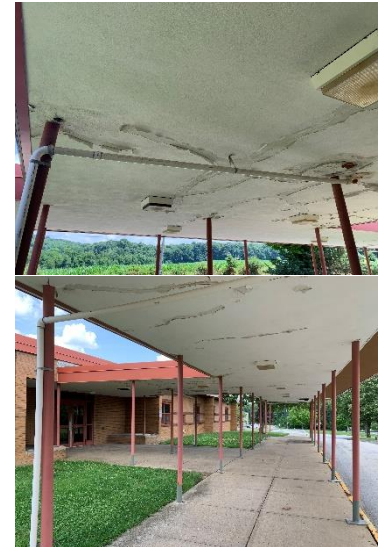
IMPROPER DRAINAGE AND PEELING
PAINT AT BOTH CANOPIES

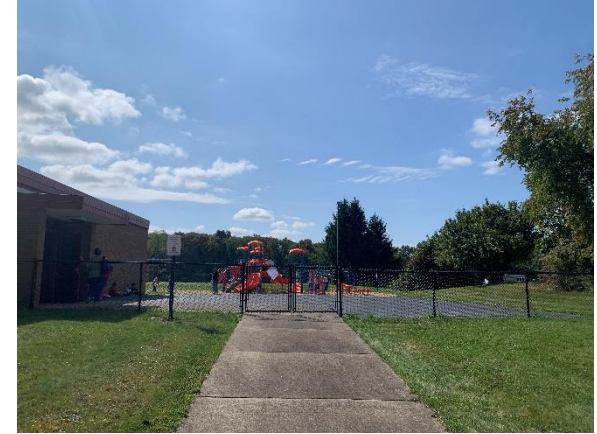
BROKEN CONCRETE

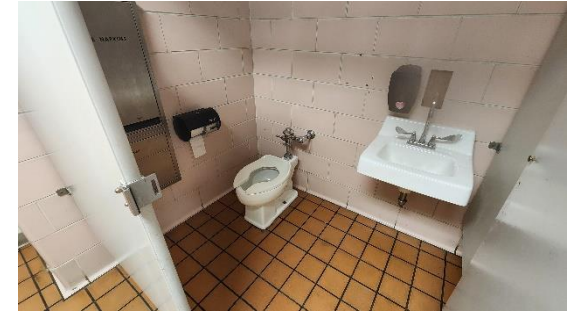
NO VERTICAL GRAB BARS AND NONCOMPLIANT CONFIGURATION

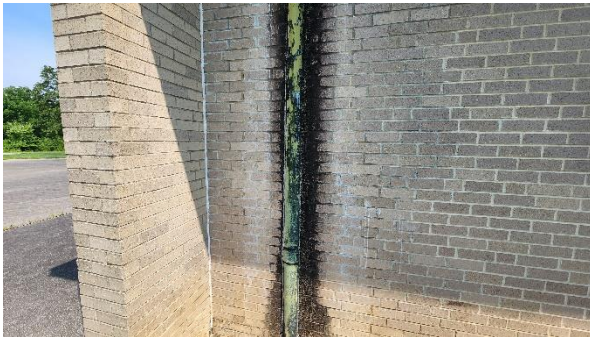
MILDEW PRESENT AT EXTERIOR LOCATIONS

- Recaulking around window and door jamb, heads, and sills is necessary. This should be implemented into yearly routine maintenance.
- Some exterior doors are rusted and do not close properly.
 - Recommendation: Replace trouble doors as necessary or replace all exterior doors as future project.
- Metal paint in some locations (doors and window trim) is faded and worn.
 - Recommendation: Paint as necessary. Routine maintenance should be performed as required.
- Mold/ mildew present in some building exterior locations.
 - Recommendation: Clean exterior surfaces, as necessary. Routine maintenance and inspection necessary to check for water damage and leaking in these areas.

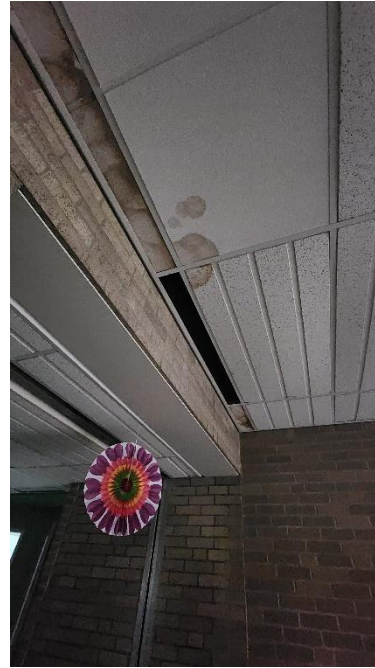
WATER STAINS WHERE ADDITION
MEETS ORIGINAL BUILDING

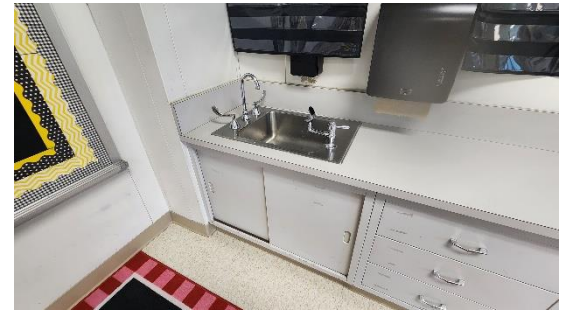
DAMAGED CASEWORK WITH SIDE APPROACH

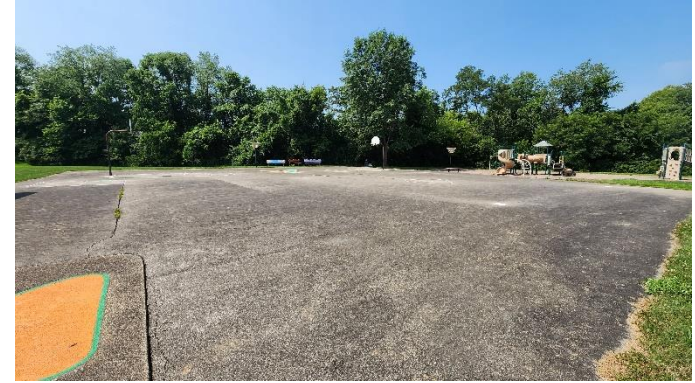
CRACKS IN ASPHALT AT PLAY AREA. LARGE PAVED AREA, SMALL PLAYGROUND

- Minor asphalt and concrete cracking is present throughout site – Sidewalks, curbs, and parking lot pavement. Cracking does not impede travel.
 - Recommendation: For concrete paving, routine maintenance required and repair as necessary.
 - Recommendation: At asphalt paving, have geotechnical evaluation to determine the condition of the paving depth and sub-base. The geotechnical evaluation will determine if an overlay, milling and overlay or full depth replacement is needed. Plan for a paving project in the near future.
- District reports that playgrounds are in bad shape. Cracking present in asphalt of play area/ basketball area.
 - Recommendation: Repair and patch asphalt as necessary. Replace playground equipment at end of useful life. Playground updates and lot repaving could be joined into one larger exterior renovation project.

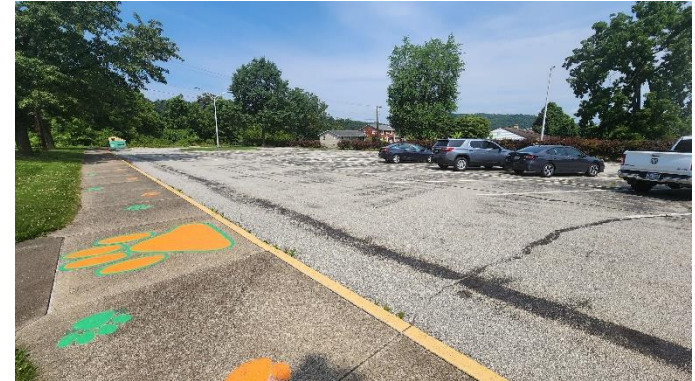
CRACKS IN ASPHALT AND CONCRETE AT FACULTY LOT

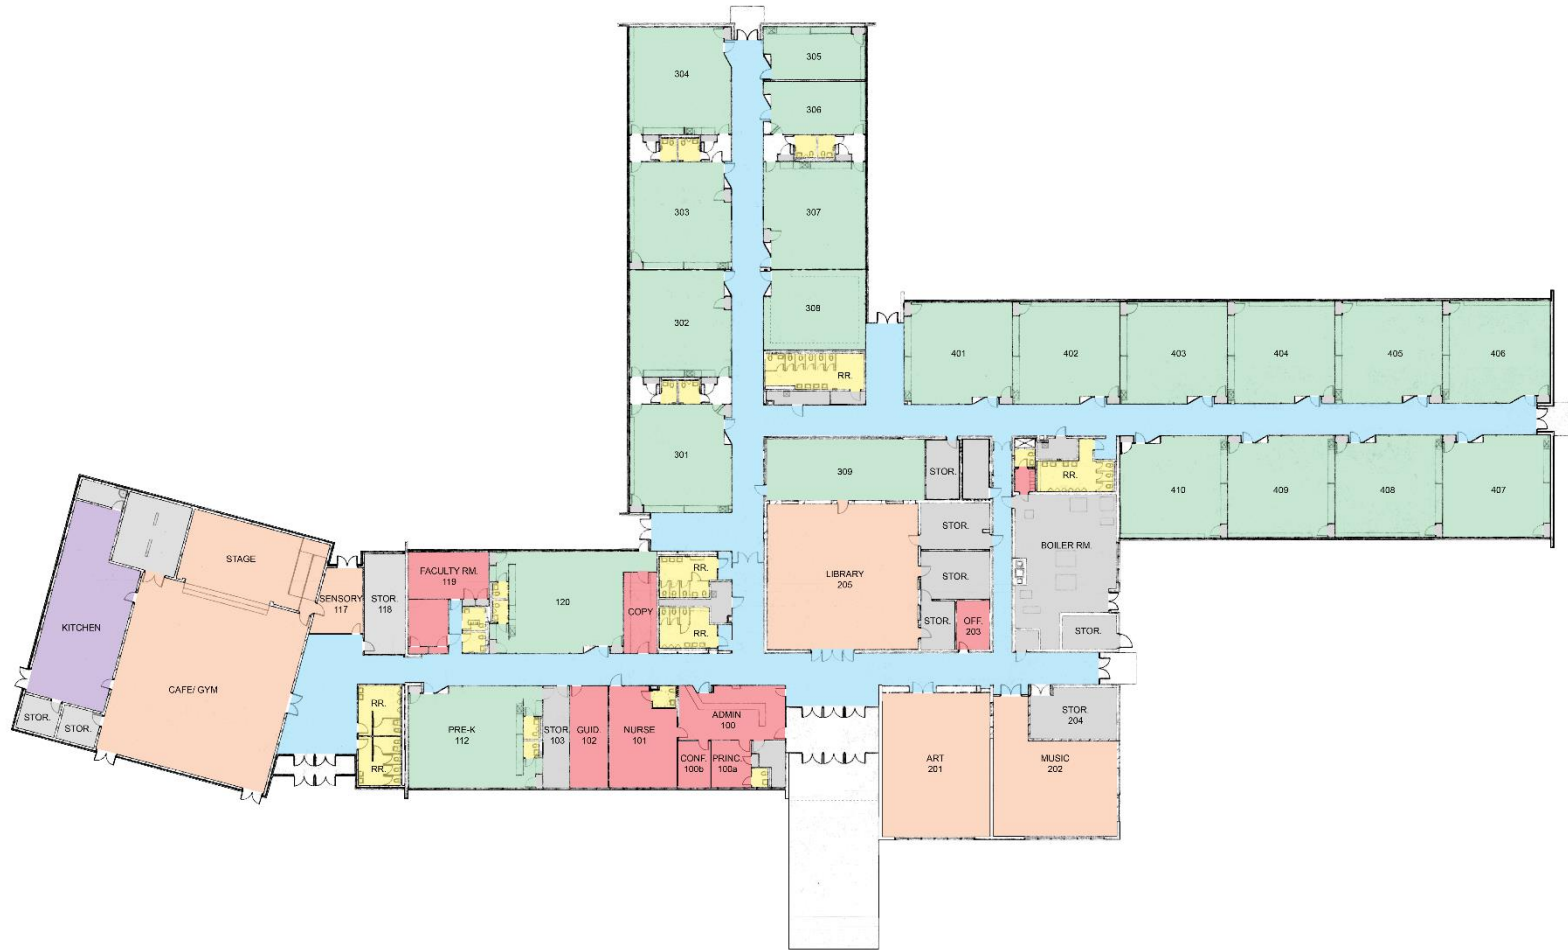
ROOF LEAKING AND WATER STAINING PRESENT AT THESE LOCATIONS. LINES DELINEATE THE 1994 ADDITION BOUNDARY AND PLACEMENT OF LARGE SKYLIGHT.

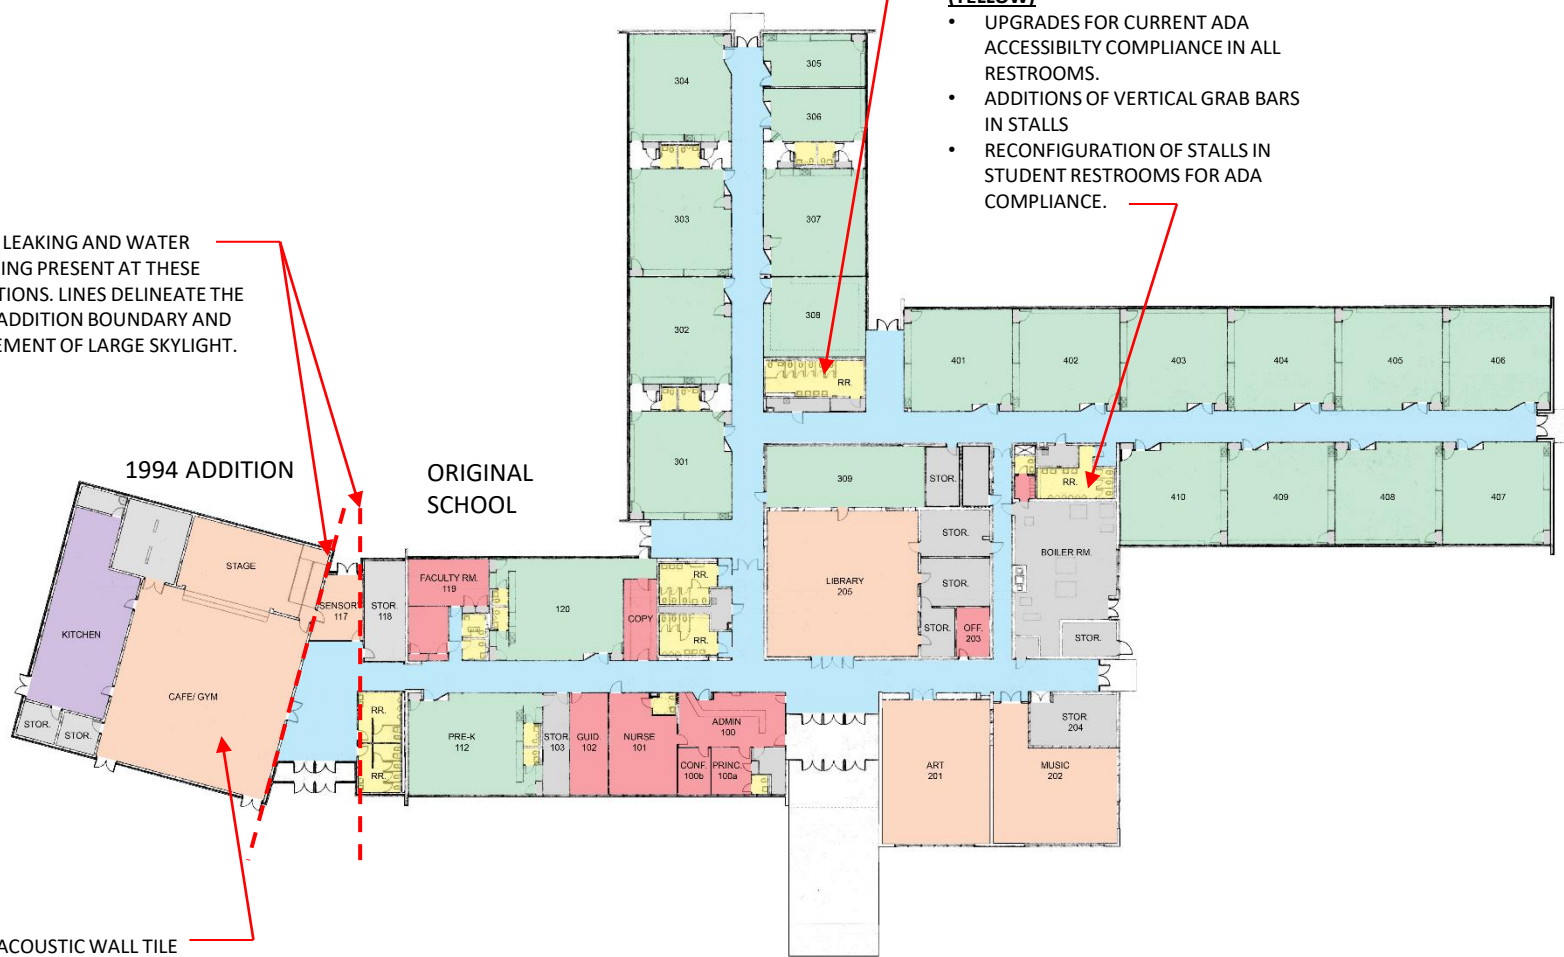
ADDITIONAL ACOUSTIC WALL TILE NECESSARY IN THE CAFETERIA/ GYM.

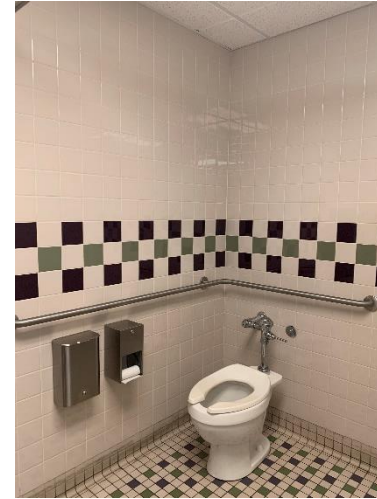
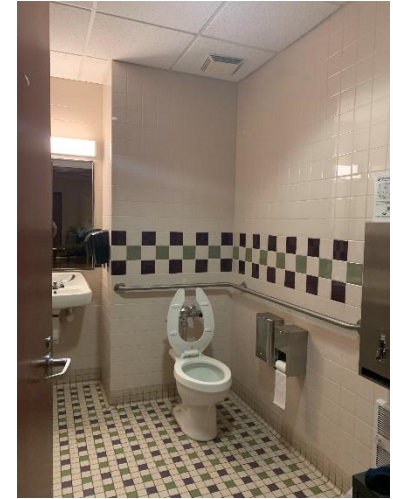
VERTICAL GRAB BARS NECESSARY IN STUDENT RESTROOMS AND NURSE'S SUITE

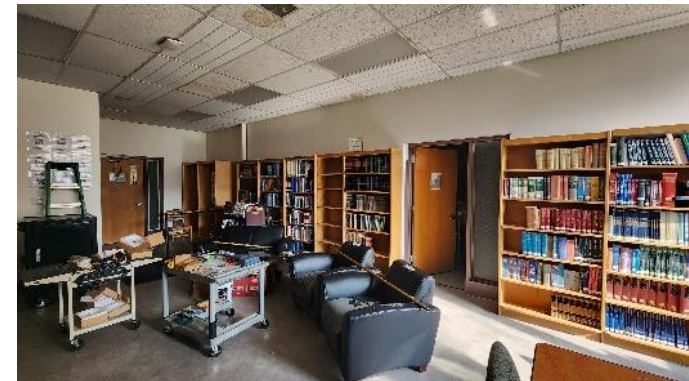
VISIBLE WATER INFILTRATION IN CEILING

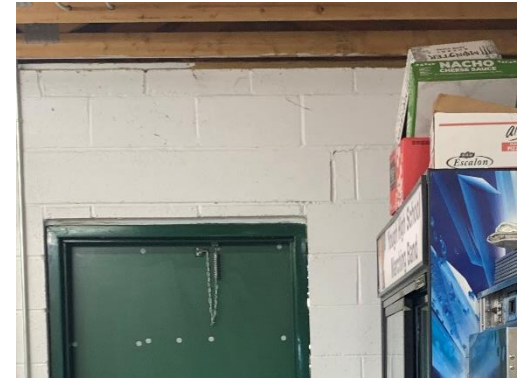
CRACK PRESENT IN BAND CONCESSION

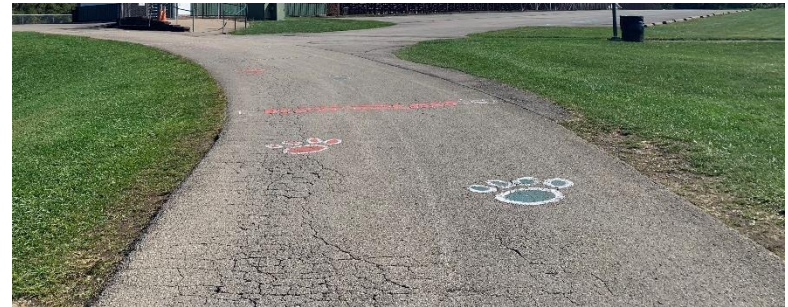
CRACKING PRESENT FROM HEAVY MACHINE USE. PRESENT THROUGHOUT SITE
