District Wide Facility Assessment

Yough School District

April 8, 2024

District-Wide Facility Study

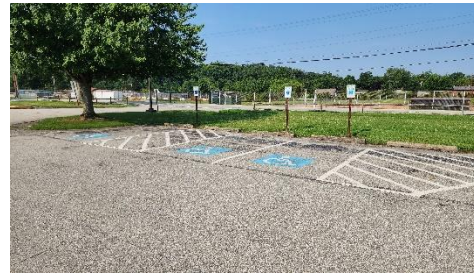
NO PAINT FOR ADA TRAVEL PATH

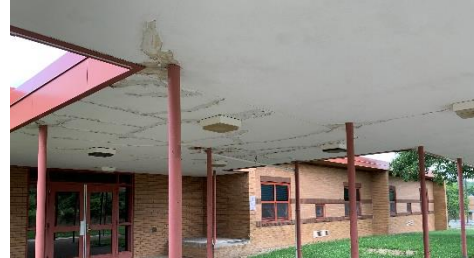
EXTERIOR PAINT MAINTENANCE

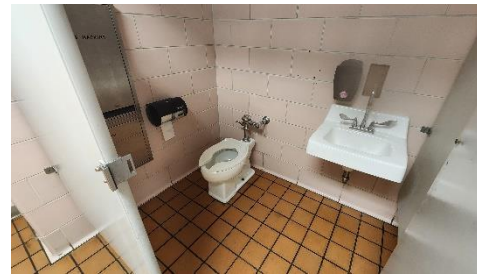
ADA UPGRADES IN ALL RESTROOMS

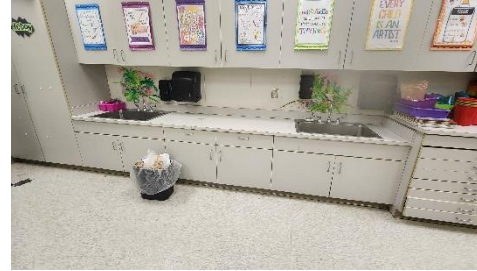
ADA APPROACH FOR CASEWORK SINKS

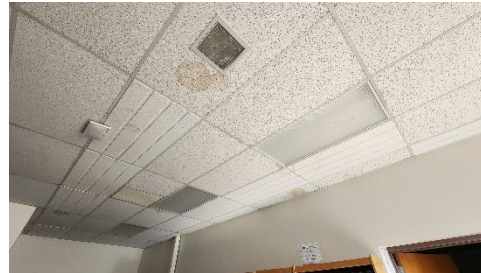
WATER STAINING AT HVAC SYSTEMS

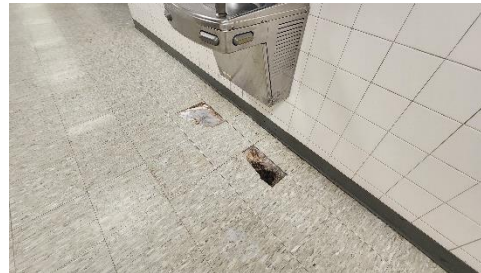
MISSING FLOOR FINISHES

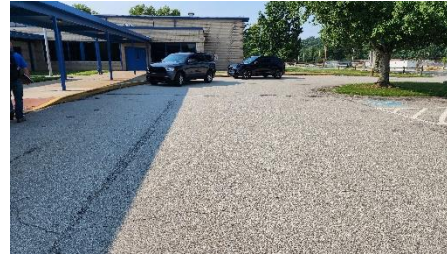
NO ADA ACCESS ROUTE FROM PARKING

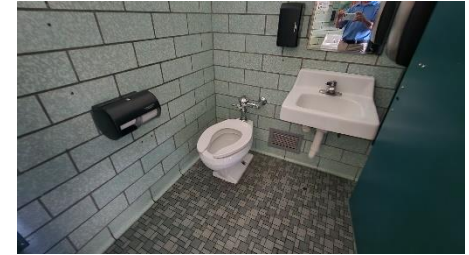
ADA UPGRADES IN ALL RESTROOMS

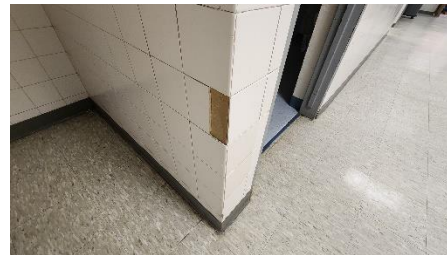
MISSING WALL FINISHES

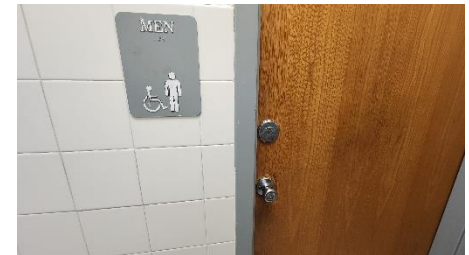
NON – ADA COMPLIANT DOOR HARDWARE

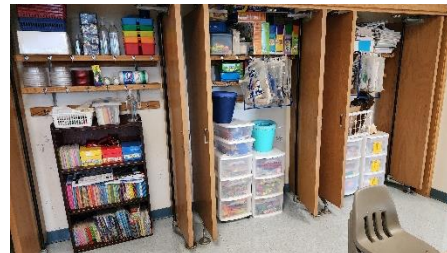
STUDENT STORAGE AS TEACHER STORAGE

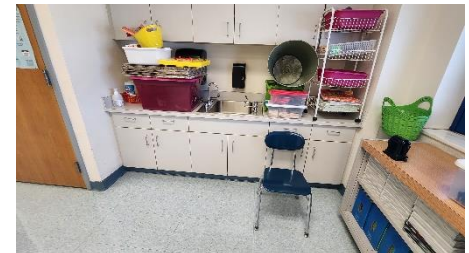
NON – ADA COMPLIANT SINK APPROACH

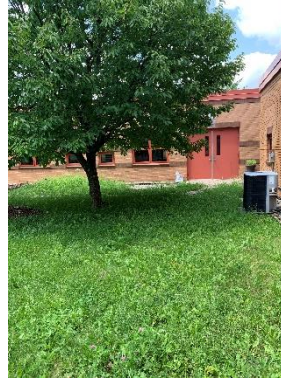
COURTYARD LANDSCAPE

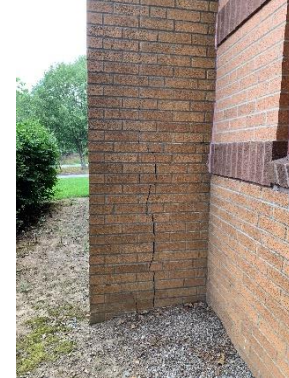
WALL CRACKING

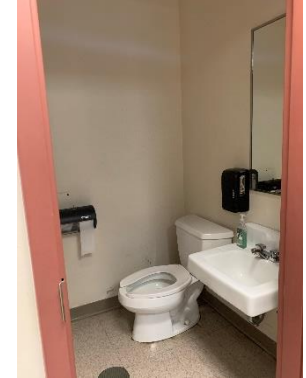
NON – COMPLIANT ADA
RESTROOM

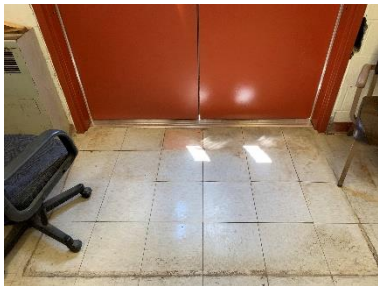
WORN FLOOR TILES

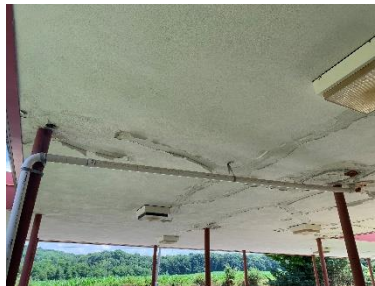
DETERIORATED CANOPY

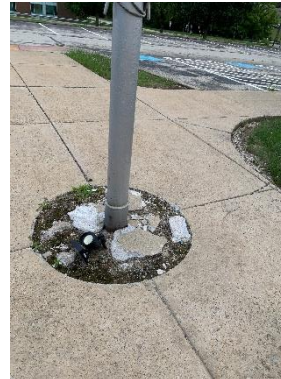
DETERIORATED PAVING

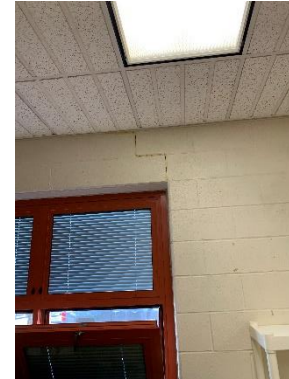
INTERIOR STEP CRACK

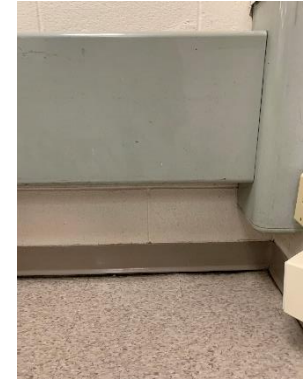
WALL PULLING FROM
FLOOR

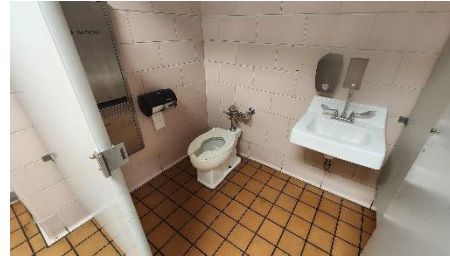
NON – ADA COMPLIANT RESTROOMS

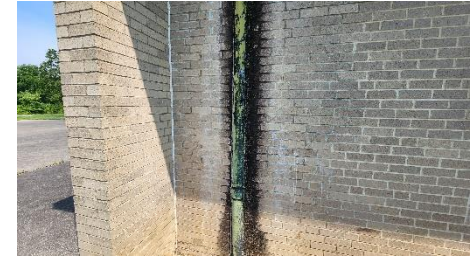
MILDEW BUILD UP ON EXTERIOR

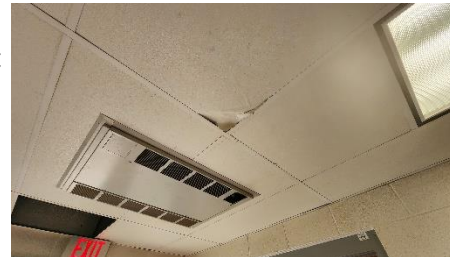
ACT DAMAGE

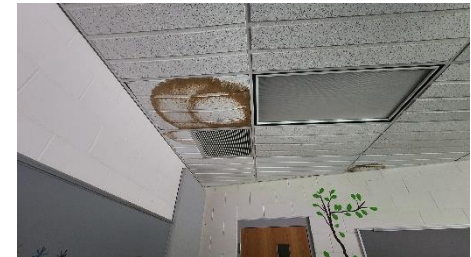
WATER STAINING AT HVAC SYSTEMS

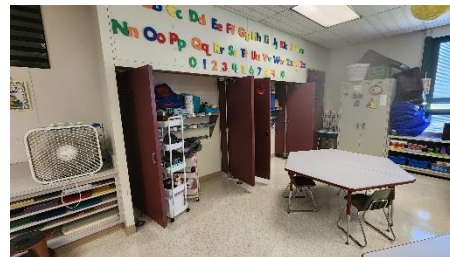
STUDENT STORAGE AS TEACHER STORAGE

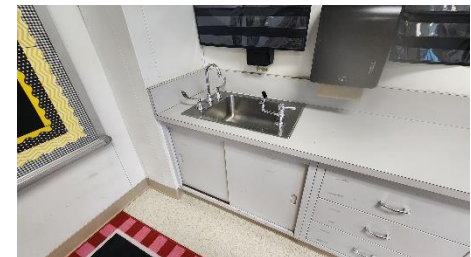
NON – ADA COMPLIANT SINK APPROACH

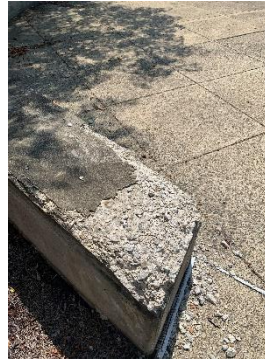
DETERIORATING
CONCRETE

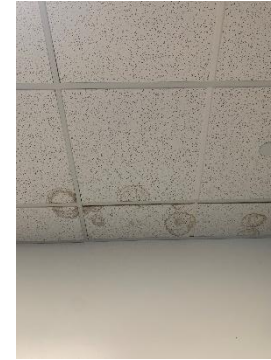
WATER STAINING AT
HVAC SYSTEMS

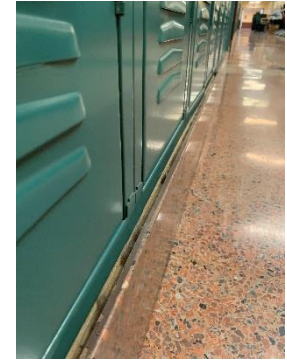
PULLING INTERIOR
FINISHES

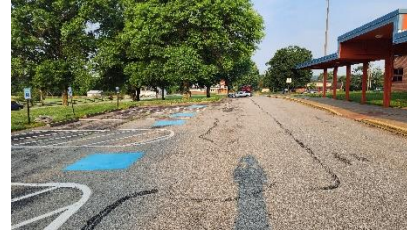
NO PAINT FOR ADA TRAVEL PATH

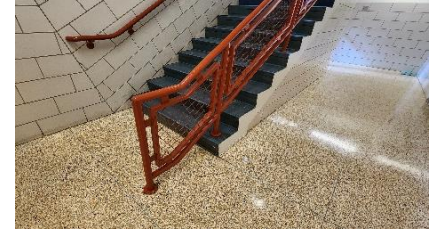
NON – ADA COMPLIANT GUARDRAILS

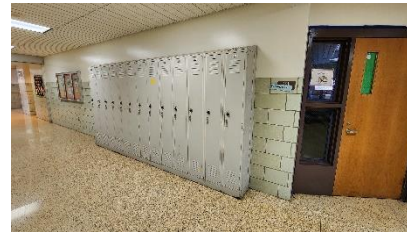
DAMAGED STUDENT LOCKERS

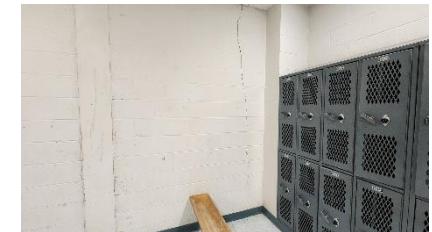
INTERIOR WALL CRACKS

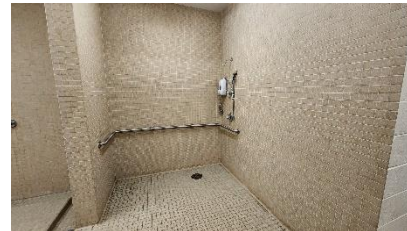
NON – ADA COMPLIANT SHOWERS

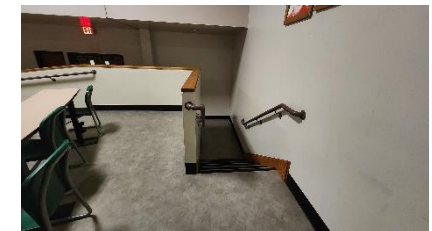
ADA APPROACH AT LGI

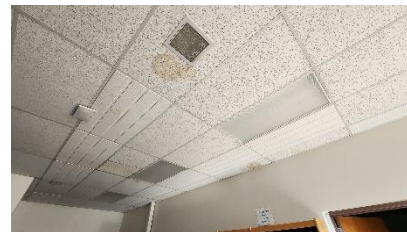
WATER STAINING AT HVAC SYSTEMS

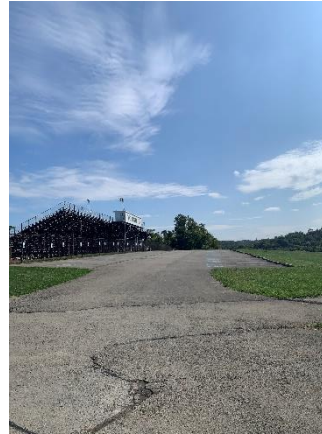
CRACKS IN PAVEMENT

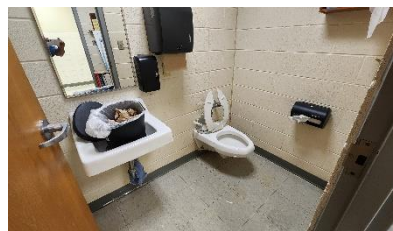
- All student restrooms, faculty toilets, and nurse's toilet need a vertical grab bar to meet current ADA code.
 - **Recommendation:** Install vertical grab bars to meet current codes in all restrooms and faculty toilets.

NO GRAB BARS

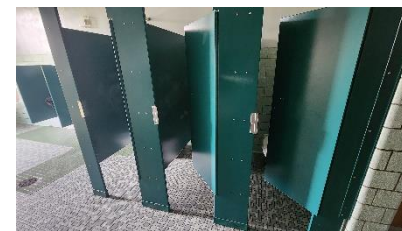
- All student restrooms need reconfiguration for current ADA plumbing code, which includes a dedicated ADA stall with no sink.
 - **Recommendation:** Possible student restroom reconfiguration is necessary to provide adequate fixtures and layout for current code.

RECONFIGURE ADA STALL FOR CURRENT CODE

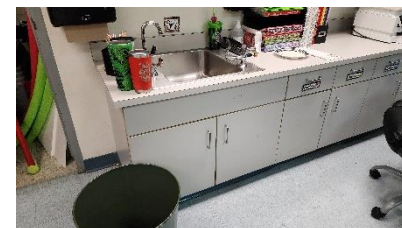
CURRENT SIDE APPROACH CASEWORK

- **Recommendation:** If casework is replaced in this future, it should be considered to modify the casework to provide the pull under approach to the sink.

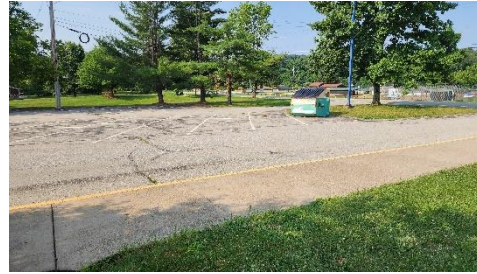
- Parking is limited on site during the school day but especially during off hour events. This leads to parents parking across the street. It is a safety hazard to have parents and children walk across the road for school functions.

LACK OF FACULTY AND VISITOR PARKING

- Parent drop off and pick up backs up into the city street.
 - Recommendation: *Reconfiguration of routes and parking is needed for current system. District should consider the addition of a new lot adjacent to the current faculty lot.*

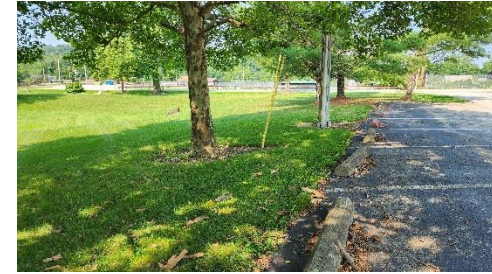
POSSIBLE NEW LOT LOCATION

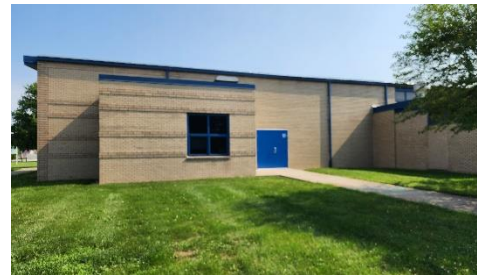
SECURITY SYSTEMS AT ALL EXTERIOR DOORS

- Door 10 has views to entrance and part of side parking lot. One or two cameras are needed at the door for control and security.
 - Recommendation: *Add additional security camera systems at all exterior doors.*

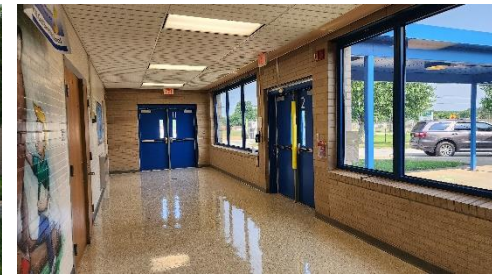
STUDENT ENTRANCE AT DOOR 2

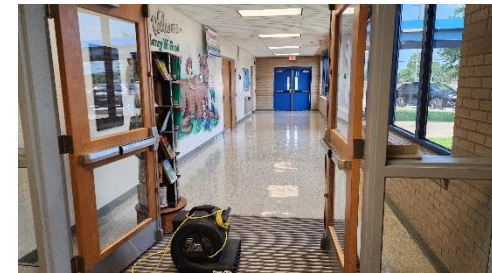
STUDENT ENTRANCE VESTIBULE

- Recommendation: *Renovate student vestibule for a secure entrance with no access to school programmatic spaces.*
- Door 9 needs a bell and possibly a camera for deliveries.

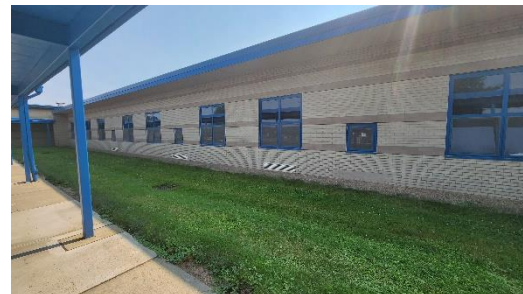
- Windows in decent shape other than a couple missing screens. Screens missing at classroom 112, 121, and 123. Screens missing at math lab. Screens ripped at classroom 101 and 122.

WINDOW REPLACEMENT AND MAINTENANCE AS NECESSARY

- Recommendation: Replace windows screens, as necessary. Inspect all frames for damage and paint as necessary.
- Doors do not lock or close properly. Currently being replaced.

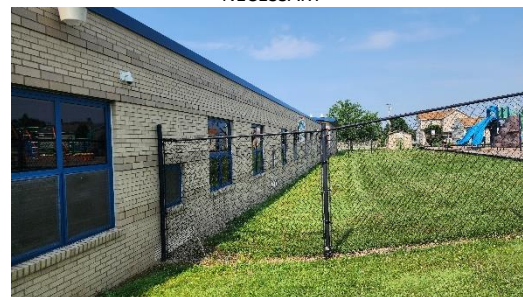
- Recommendation: none
- Both playgrounds are newly constructed. District is asking for a shade space at the large playground and new mulch.
- Swing area needs new mulch and something to contain that material.

MAINTENANCE AROUND PERIMETER AND PLAY AREAS

- Recommendation: Routine maintenance and fill of playground mulch.
 - Recommendation: Provide canopy for sun protection. Location TBD.

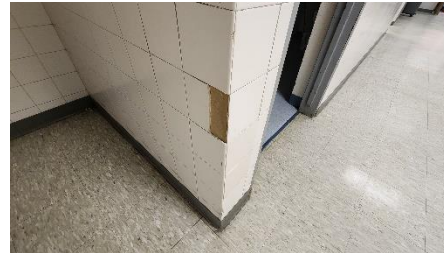
- Existing hallway wall tile is nearing the end of its useful life. Wear is significant in admin hallway.
 - Recommendation:** *Replace and patch wall tile, as necessary. Maintain a yearly inspection of wall tile.*

MISSING WALL TILE

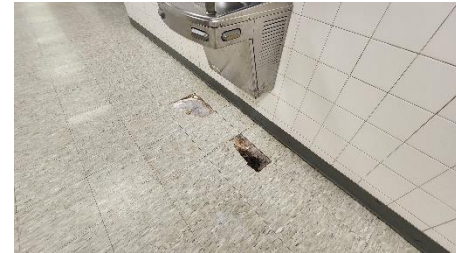
- Existing VCT flooring is showing sign of wear and nearing the end of its useful life. Pieces are lifting and, in some areas, missing.
 - Recommendation:** *Yearly inspection of flooring and repairs, as necessary.*

MISSING FLOOR TILE

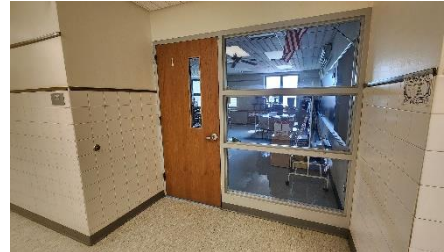
- Door side lights have been upgraded with 3M impact resistant film.
 - Recommendation:** *none*
- Existing student cubby system doubles as teacher storage. District has requested designated student cubbies or lockers in hallway.

SIDELIGHT UPGRADED WITH IMPACT FILM

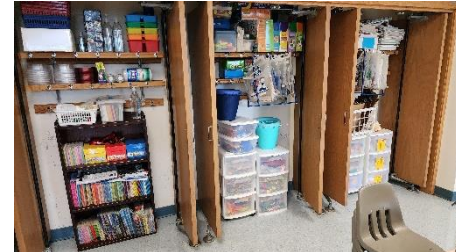
CURRENT STUDENT AND TEACHER STORAGE

- Recommendation:** *Change current classroom closet storage to student cubby storage, add additional teacher storage. A larger scale option includes renovations to hallway to include student lockers.*

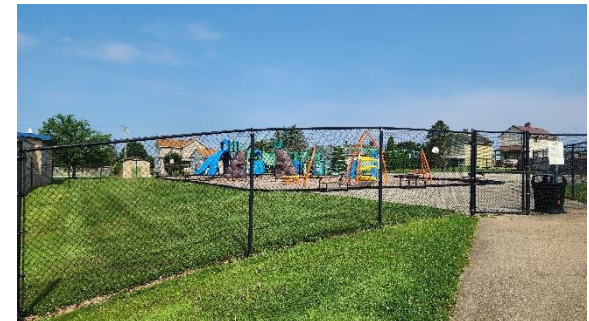
NEW PLAY AREA – ROUTINE MAINTENANCE

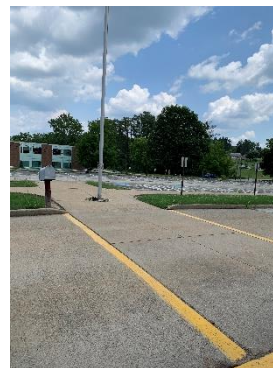
ADA TRAVEL PATH NECESSARY FROM ASSIGNED ADA PARKING

- Recommendation: Paint ADA travel path and mark ADA accessible spot in correct locations. This can be grouped with a future complete lot repainting project.

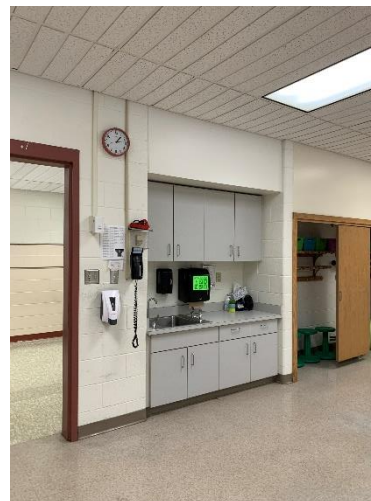
- All classroom sinks are required to have an ADA approach. Side approach is allowed but front approach is preferred.
 - Recommendation: If casework is replaced in this future, it should be considered to modify the casework to provide the pull under approach to the sink.

CURRENT SIDE APPROACH AT CLASSROOM CASEWORK

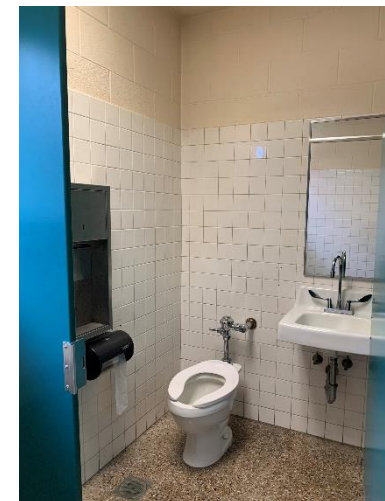
- All student restrooms, faculty toilets, and nurse's toilet need a vertical grab bar to meet current ADA code.
 - Recommendation: Install vertical grab bars where missing.

- All student restrooms need reconfiguration for current ADA accessibility code, which includes a dedicated ADA stall with no sink.
 - Recommendation: Reconfigure toilet rooms as necessary to provide adequate fixtures and layout for current code.

VERTICAL GRAB BARS AND SINK REMOVAL FROM ALL ADA STALLS NECESSARY

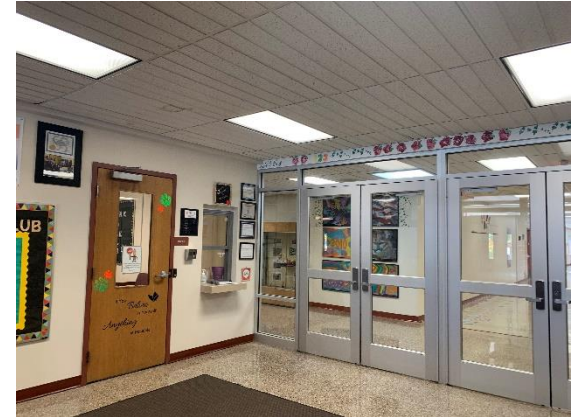
CONTROLLED ADMIN ACCESS

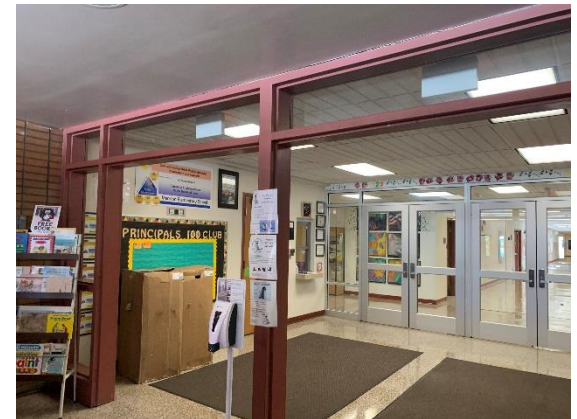
EXISTING FRAME TO REMAIN

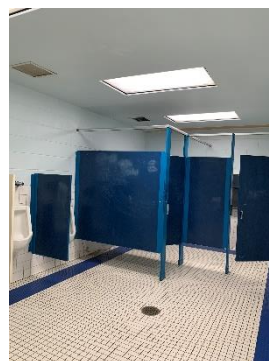
- Recommendation: Determine the cause of the movement by engaging a Structural Engineer for further investigation.
- Toilet partitions scratched and showing signs of wear.

DAMAGED TOILET PARTITIONS

- Recommendation: Replace partitions, as necessary. Can be grouped with a complete restroom renovation project to resolve ADA accessibility issues.

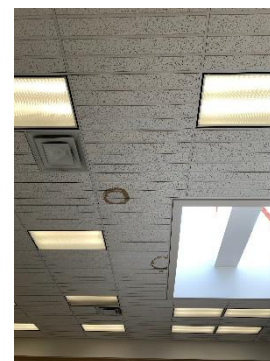
- Water staining at the ceiling systems was recorded throughout building. It should be noted that staining was present in multiple classrooms spaces adjacent to ceiling mounted mechanical units. It is also present at skylights and the location of the 1994 addition to the original school.

LEAKING/ STAINING AT HVAC SYSTEMS AND SKYLIGHT

- Recommendation: Inspection to determine the cause of water leaking should be performed and the issues corrected. Yearly inspection of ceiling and mechanical systems should be performed, and repairs done, as necessary. Replacement of ceiling tiles should be done, as necessary.

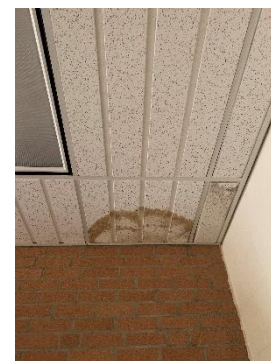
LEAKING/ STAINING AT JOINT OF NEW ADDITION

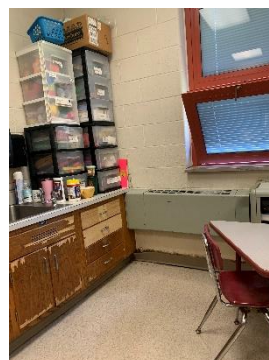
- Sinking or shifting of slab in room 101, 105, 201, and 205. Rubber base at these floors pulling away from floor and wall. Currently, the settling/heaving does not present any trip hazard to faculty/ students.

FLOOR OR WALL SHIFTING. SEPARATION OF FLOOR BASE

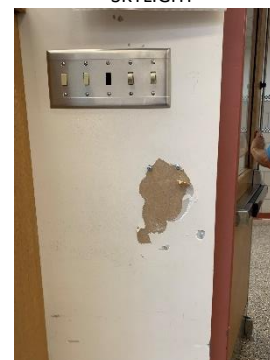
- Miscellaneous interior floor and wall damage.
 - Recommendation: Routine school-wide maintenance necessary

DAMAGED WALL FINISHES

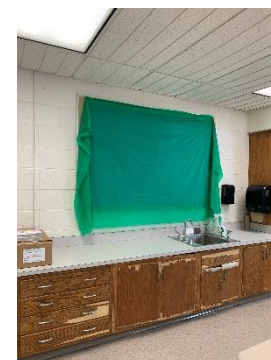
- The built-in casework systems in classrooms are worn and outdated.
 - Recommendation: Consideration can be given to replacing the worn casework but not critical. Replacement of casework and sinks to provide ADA Accessibility is recommended.

AGED CASEWORK

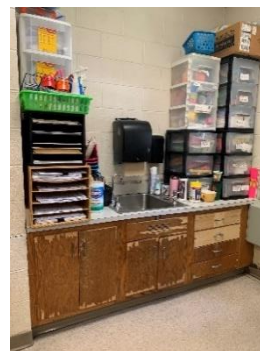
CASEWORK EXAMPLE

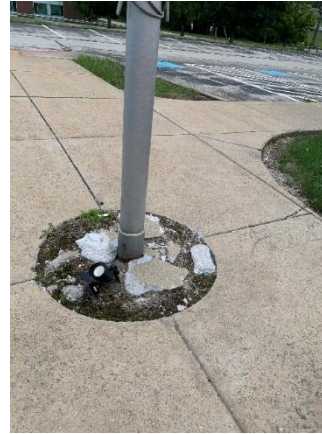
- Minor asphalt and concrete cracking is present throughout site – Sidewalks, curbs, and parking lot pavement. Cracking does not impede travel.
 - Recommendation: Routine maintenance required and repair as necessary.
- Concrete around flagpole is disintegrated.
 - Recommendation: Routine maintenance required and repair as necessary.
- Cracked asphalt and missing asphalt at back playground. Uneven walkway from concrete to asphalt. Playground's asphalt is currently being resealed.
 - Recommendation: After resealing project, routine maintenance and repairs are required.
- New playground equipment replaced over the summer.

BROKEN CONCRETE

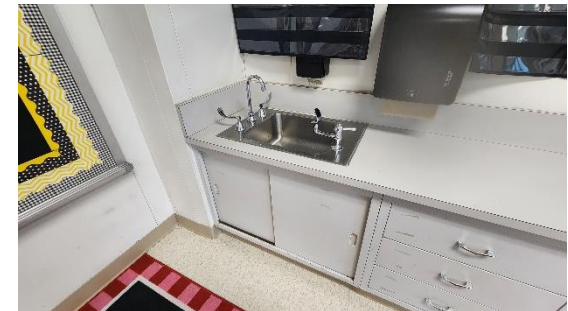
SIDE SINK APPROACH

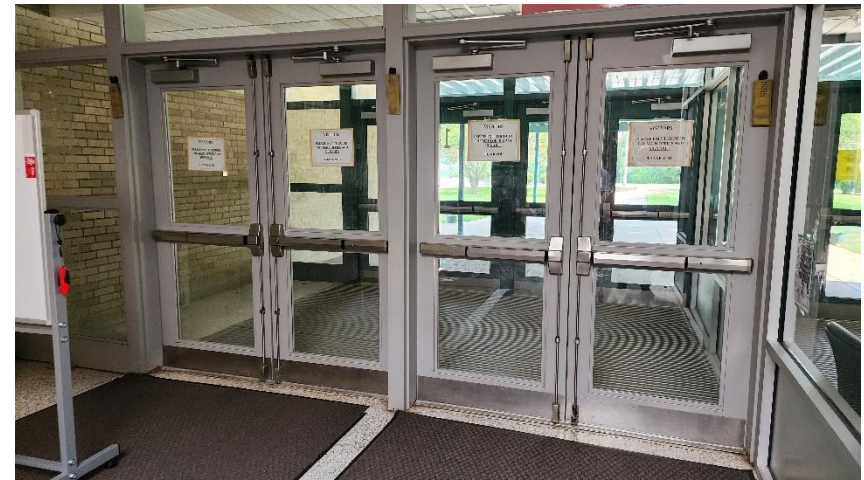
VISITOR SIGNAGE AT INTERIOR OF VESTIBULE. SIMILAR SIGNAGE TO BE PLACED ON EXTERIOR.

- Controlled access to administrative suite is in place. No reported issues with access to administrative suite during school hours.
- Door side lights have been upgraded with 3M impact resistant film.
 - Recommendation: none
- Directional signage for visitors at secondary as well as main entrance is not provided. These are required by code.
 - Recommendation: Signage should be placed at all secondary entrance doors directing visitors to the main entrance. The main entrance shall have signage instructing visitors to sign in at the office upon entering.

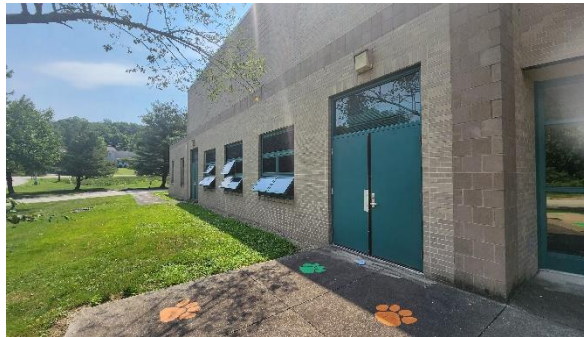
ROUTINE MAINTENANCE OF EXTERIOR DOORS AND WINDOWS

- Recaulking around window and door jamb, heads, and sills is necessary. This should be implemented into yearly routine maintenance.
- Some exterior doors are rusted and do not close properly.
 - Recommendation: Replace trouble doors as necessary or replace all exterior doors as future project.
- Metal paint in some locations (doors and window trim) is faded and worn.
 - Recommendation: Paint as necessary. Routine maintenance should be performed as required.
- Mold/ mildew present in some building exterior locations.
 - Recommendation: Clean exterior surfaces, as necessary. Routine maintenance and inspection necessary to check for water damage and leaking in these areas.

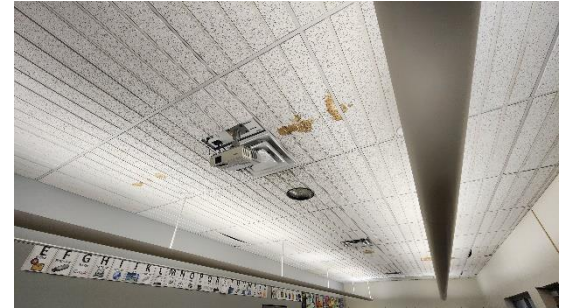
- Water staining at the ceiling systems was mainly localized to adjacent to ceiling mounted mechanical units. Continued water saturation could foster mold growth from long term water exposure to ceiling and adjacent systems.

WATER STAINS NEAR HVAC UNITS

- Recommendation: Inspection to determine the cause of water leaking should be performed and the issues corrected. Yearly inspection of ceiling and mechanical systems should be performed, and repairs done, as necessary. Replacement of ceiling tiles should be done, as necessary.

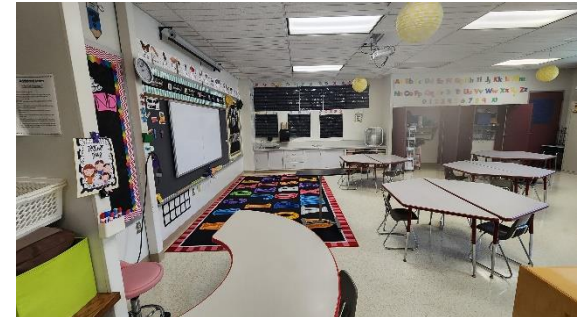
CLASSROOM CASEWORK

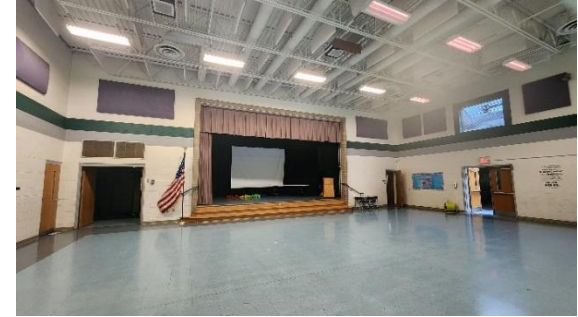
- Space is adequate for the current enrollment. No reported issues regarding size or scheduling conflicts.
- The district has reported that it does get loud during class time.
 - *Recommendation: 30% of the wall surface should be covered in some acoustic panel for proper treatment. These additional panels should remedy the sound issue.*
- The stage's existing technical equipment is sufficient for the use it receives. Stage is used mostly for physical education storage.
- The district is concerned about the stairs in front of the stage. They view it as a safety hazard for students during gym time.
 - *Recommendation: Remove stairs and provide a rubber nosing at the edge of the stage. Students will enter the stage from the adjacent ramp.*

MULTIPURPOSE RM: STAGE, ACOUSTIC TREATMENT, FINISHES

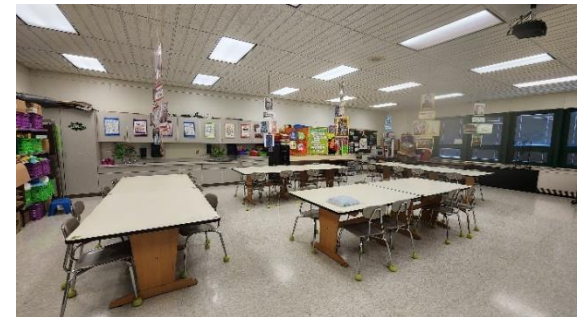
- Size and layout of the room is sufficient and functions well during school hours.
- Finishes are in decent condition and should continue to serve the district for another 5 – 10 years. The district is interested in new wall treatment to bring some color into the space.
 - *Recommendation: The district could paint a couple walls with an accent color on their own. A complete room renovation would allow for new, colorful wall and floor finishes.*
- One of the two existing sinks should be ADA accessible with a front or side approach.
 - *Recommendation: Alter sink casework at one fixture to allow an ADA front or side approach. A total casework upgrade could occur to provide more storage, modern finishes, and ADA standards.*

ART ROOM CASEWORK AND LAYOUT

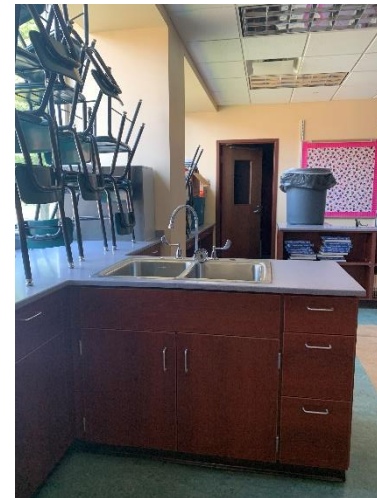
AT LEAST ONE SINK IN FCS CLASSROOM SHOULD BE ADA ACCESSIBLE

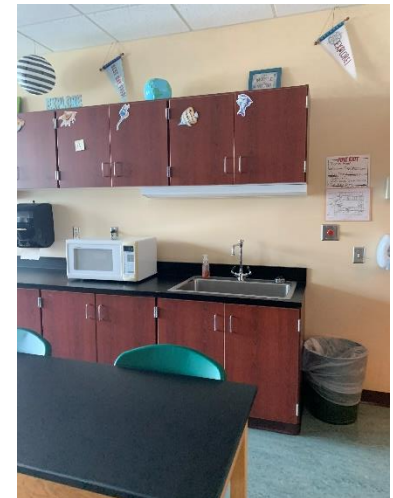
SINKS IN CLASSROOM CASEWORK DO NOT HAVE FRONT OR SIDE APPROACH

- Recommendation: *If casework is replaced in this future, it should be considered to modify the casework to provide the pull under approach to the sink.*

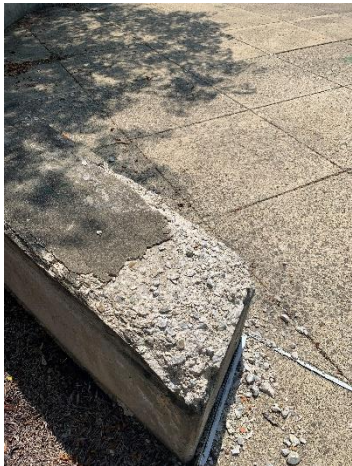
DETERIORATING CONCRETE AT
ENTRANCE

- New concrete work needs to be addressed on the border of entrance 1/ flagpole entrance.
 - Recommendation: repair broken concrete as necessary. Routine inspection is required.
- There is one cracked window in wrestling room.
 - Recommendation: Repair window and keep up with routine maintenance, as necessary.
- Landscape in front of building near main entrance.
 - Recommendation: Replant and routine maintenance, as necessary.

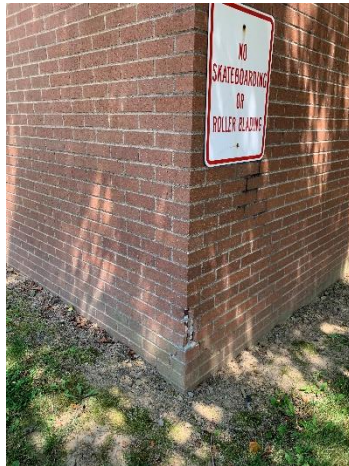
MISC. BROKEN EXTERIOR BRICK
VENEER

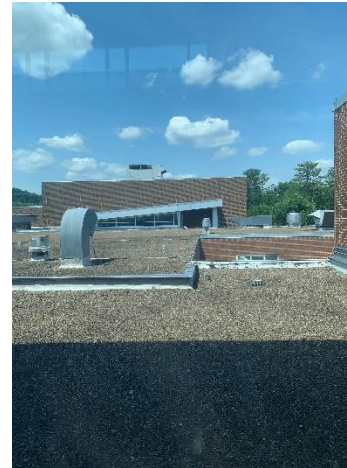
- No major defects or damage was observed during review.
- Leaks have been reported in various parts of the building. It is to be determined whether leaks are coming from HVAC systems or a roof compromise.
 - Recommendation: Routine inspections of problem areas and repair as necessary.

ROUTINE MAINTENANCE OF ROOF

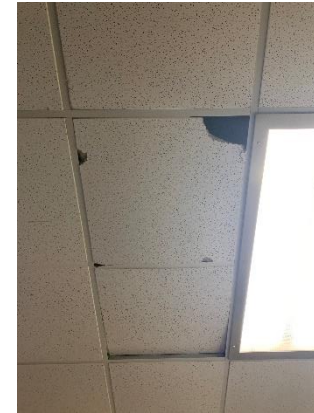
DAMAGED CEILING TILES

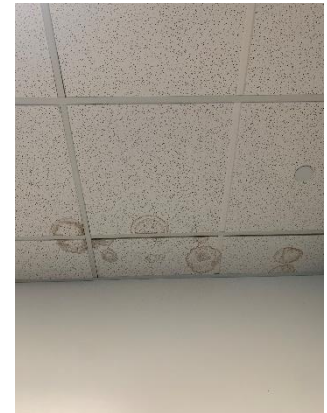
WATER-STAINED CEILING TILES

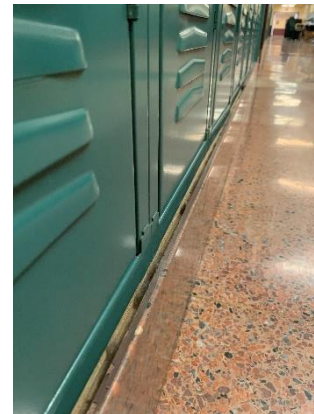
FINISHES PULLING AWAY
FROM WALLS

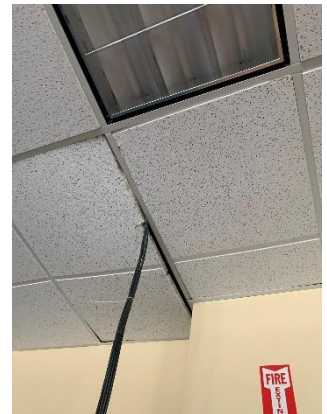
WIRES PROTRUDING FROM
CEILING TILES

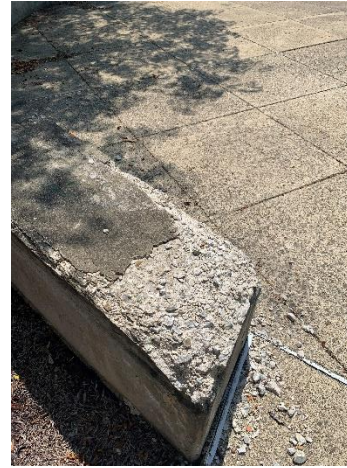
- Cracking was observed in the asphalt and concrete near the entrance.
 - Recommendation: *Repair broken concrete and asphalt as necessary.*

DETERIORATING CONCRETE AT
ENTRANCE

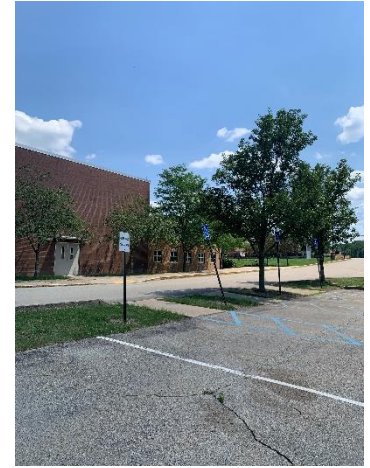
CRACKED ASPHALT IN PARKING
LOT

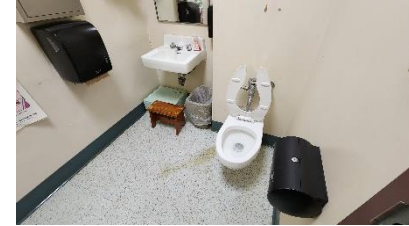
- All student restrooms, faculty toilets, and nurse's toilet need a vertical grab bar to meet current ADA code.
 - Recommendation: Install vertical grab bars to meet current codes in all restrooms and faculty toilets.

NO GRAB BARS IN RESTROOM

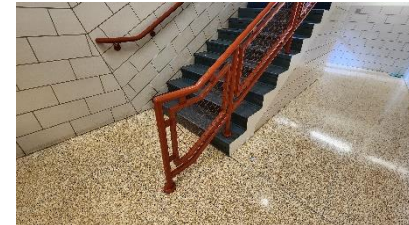
- Current stair guardrails appear to not be compliant with the current building code. Guardrails need to be a minimum 42" tall with correct spacing from the bottom of rail to stair. Incorrect spacing is a trip and entrapment hazard.

NON-COMPLIANT GUARDRAILS

- Recommendation: Replace all stair guardrails to current building code standards.

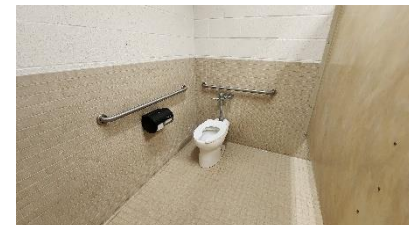
MISSING VERTICAL GRAB BAR

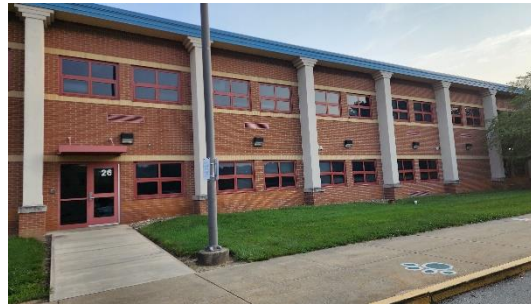
- There is mildew build up on rear exterior of school.
 - Recommendation: Routine inspections necessary to check for water infiltration. Clean as necessary.
- Windows appear to be at the end of their useful life. Many screens are missing or broken, and most blinds are inoperable.
 - Recommendation: Replace as necessary, however, if most windows building wide have issues it should be discussed to do a full system replacement.
- Additional Exterior site lighting requested by district.
 - Recommendation: Consider exterior lighting upgrades.

MISSING OR BROKEN WINDOW SCREENS

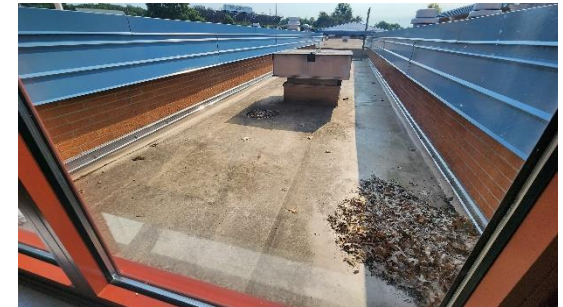
- Leaking was noted at the gym lobby.
 - Recommendation: Investigation and repairs covered by warranty. Repair made at roof and gymnasium skylight. No leaking currently present. Continue to monitor.
- From a second-floor window, it was observed that leaves collect at some points on the roof.
 - Recommendation: Routine maintenance and cleaning is necessary.

LEAVES COLLECTED ON ROOF

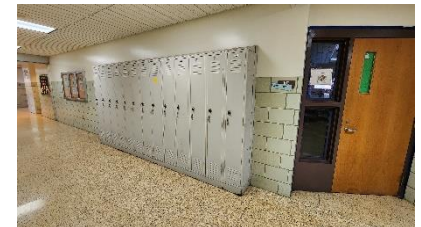
- Student lockers and gym lockers are worn and show signs of heavy use.

STUDENT LOCKERS

Lockers will be replaced in the summer of 2024.

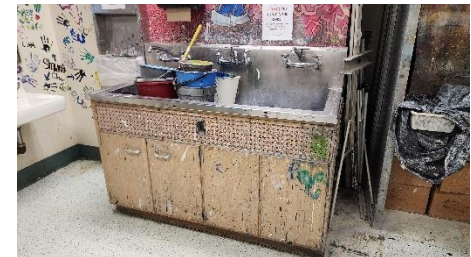
NON-ACCESSIBLE SINKS

- District has noted that its current room serves the school, but due to popularity, the art department could use a bigger space.
 - ***Recommendation:*** Discuss feasibility of expansion into adjoining rooms. If expansion is not possible, a new casework layout with appropriate storage could provide the district with a more suitable space. This would include new plumbing fixtures and workstations.

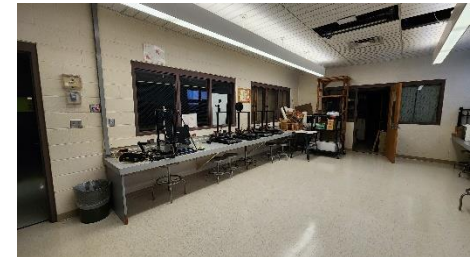
- The wood shop and adjoining CAD room are in good condition.
- Some missing ceiling tiles were noted in the CAD space, specifically the 3D printing area shown.
 - *Recommendation: Replace missing or damaged ceiling tiles throughout as required.*
- Ventilation and dust collection work properly and no issues have been reported.
- Storage in both spaces is sufficient.
- Wood shop equipment has been updated over the years and the district continues with routine maintenance.

3D PRINTING STATIONS

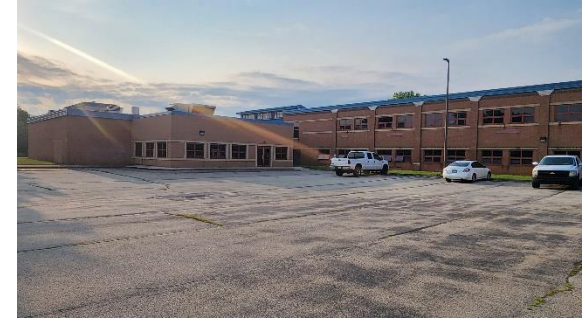
- Student lot recently repainted with lines and spot numbers. Faculty lot pictured to the right has been painted with new linework.
 - Recommendation: *routine maintenance as necessary and repaint lines as required.*

FACULTY LOT

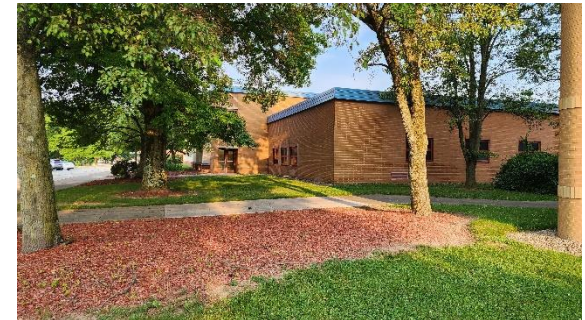
- Recommendation: *Routine maintenance as necessary*
- Exterior landscape is overgrown. Tree branches are beginning to touch the school and windows.
 - Recommendation: *Cut back tree branches near school and routine maintenance as required.*

MAINTENANCE OF VEGETATION AND MULCH

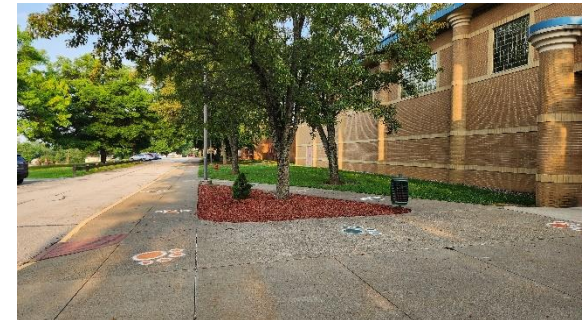
MAINTENANCE OF VEGETATION AND MULCH

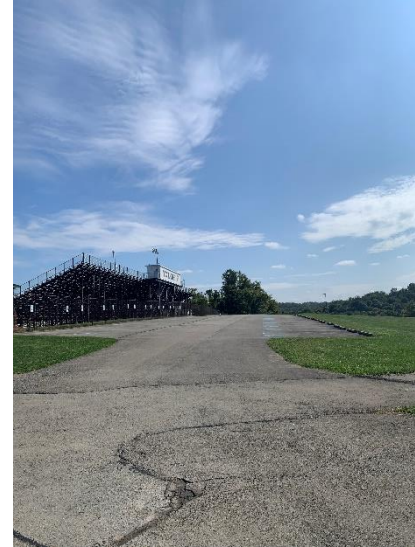
- The stadium ADA lot has clearly marked spots with paint and signage. Cracking present in lot.
 - ***Recommendation:*** Repair cracks as necessary. Can group stadium ADA lot repaving and painting with high school lot repaving as one larger project.

DESIGNATED STADIUM ADA LOT

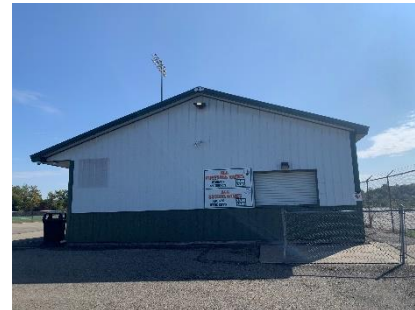
- Ticketing and concession windows should be evaluated for accessible reach ranges. Counter should be max 2'-10" to meet today's code.

TICKETING WINDOW AND COUNTER

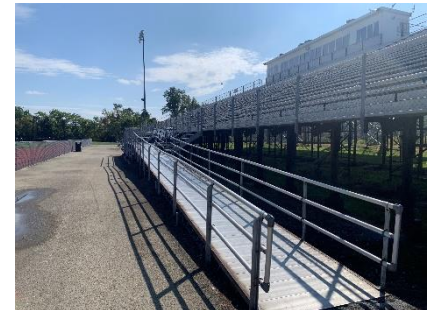
- ***Recommendation:*** Install tactile signage where missing.
- There is an ADA accessible ramp for the bleachers, and it does meet today's code. Designated space for wheelchairs is located at the top of the ramp.

ADA ACCESSIBLE RAMP FOR BLEACHERS

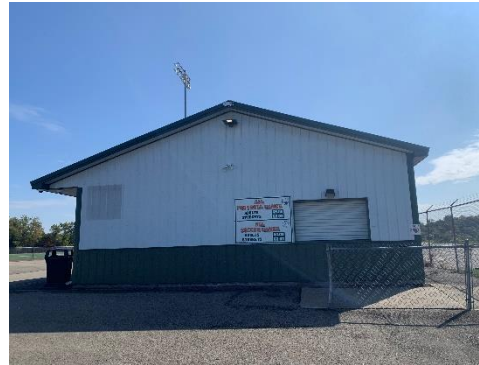
- The exterior of both concession buildings are in an overall good condition.
 - Recommendation: Routine maintenance and cleaning as necessary.
- Painted CMU exterior of restroom building in overall good condition.
 - Recommendation: Routine maintenance and cleaning as necessary. Repaint CMU block and mortar joints when required.

EXTERIOR OF TICKETING AND CONCESSION
BUILDING

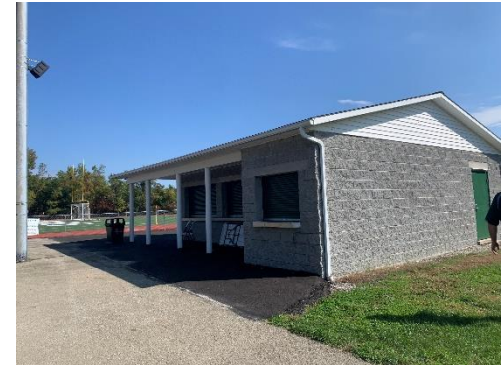
EXTERIOR OF BAND CONCESSION BUILDING

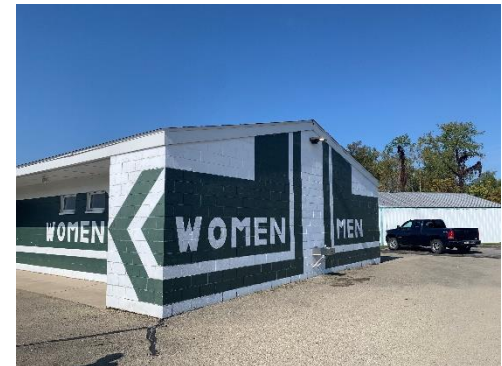
RESTROOM BUILDING PAINTED CMU

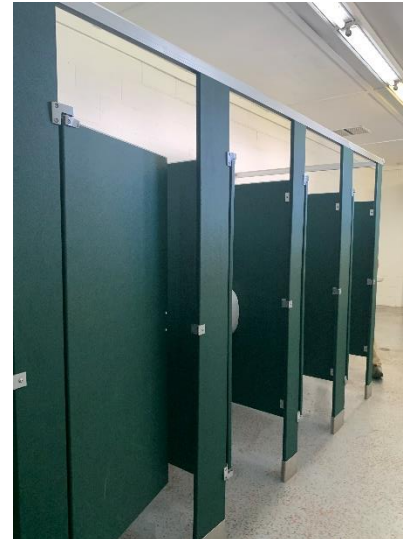
- The interior of the restroom facility is in an overall good condition. Fixtures and partitions in restrooms are in good condition.
 - Recommendation: Routine maintenance and cleaning as necessary.
- Some cracks present on painted CMU interior wall of band concession building.
 - Recommendation: Fill cracks and repaint CMU block and mortar joints when required.
- The band concession building needs extra storage or reorganization. There were multiple instances of concession items stored on top of MEP equipment.

TOILET PARTITIONS

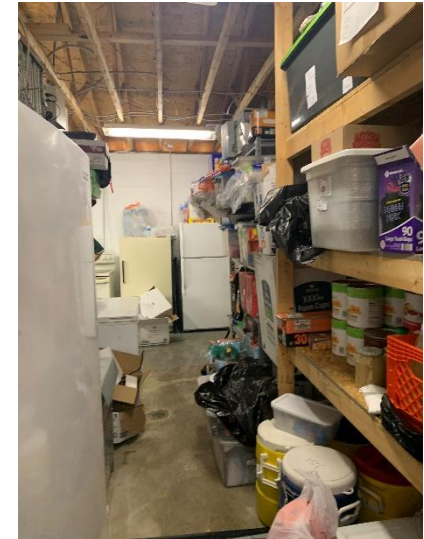
BACK STORAGE AREA OF BAND CONCESSION. STORAGE OR REORGANIZATION NECESSARY
